The City of Baltimore

Loch Raven Dam Rehabilitation

Project Update: August, 2004

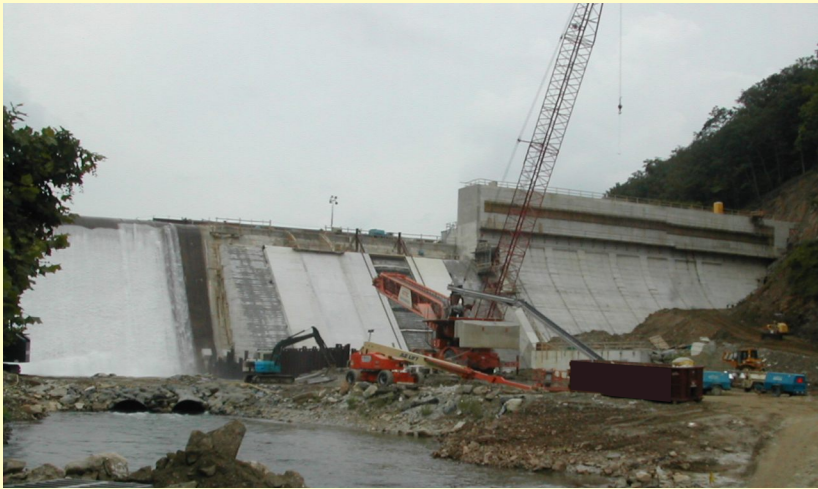
Spring,
2003

The east side of Loch Raven Dam is nearly complete! RCC Placement is finished, and conventional concrete is being placed on the east side spillway. When completed, the contractor will move the bulkhead to the west side, diverting reservoir overflow to the newly-finished half. Then, west side spillway anchors can be installed and excavation completed so that concrete placement can begin.

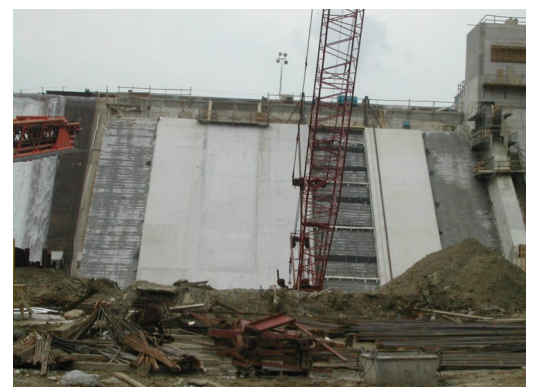
Smoothing Out the Spillway

Although most of the concrete being used to rehabilitate the dam is roller compacted, the spillway is being surfaced with conventional concrete. This smooth surface will withstand the steady friction of flowing water, providing a long-lasting finish.
